THE ARUP JOURNAL

NOVEMBER 1966

2 MODEL MAKING AT ARUPS
David Armstrong

10 RANDOM THOUGHTS ON DURABILITY
Turlogh O'Brien

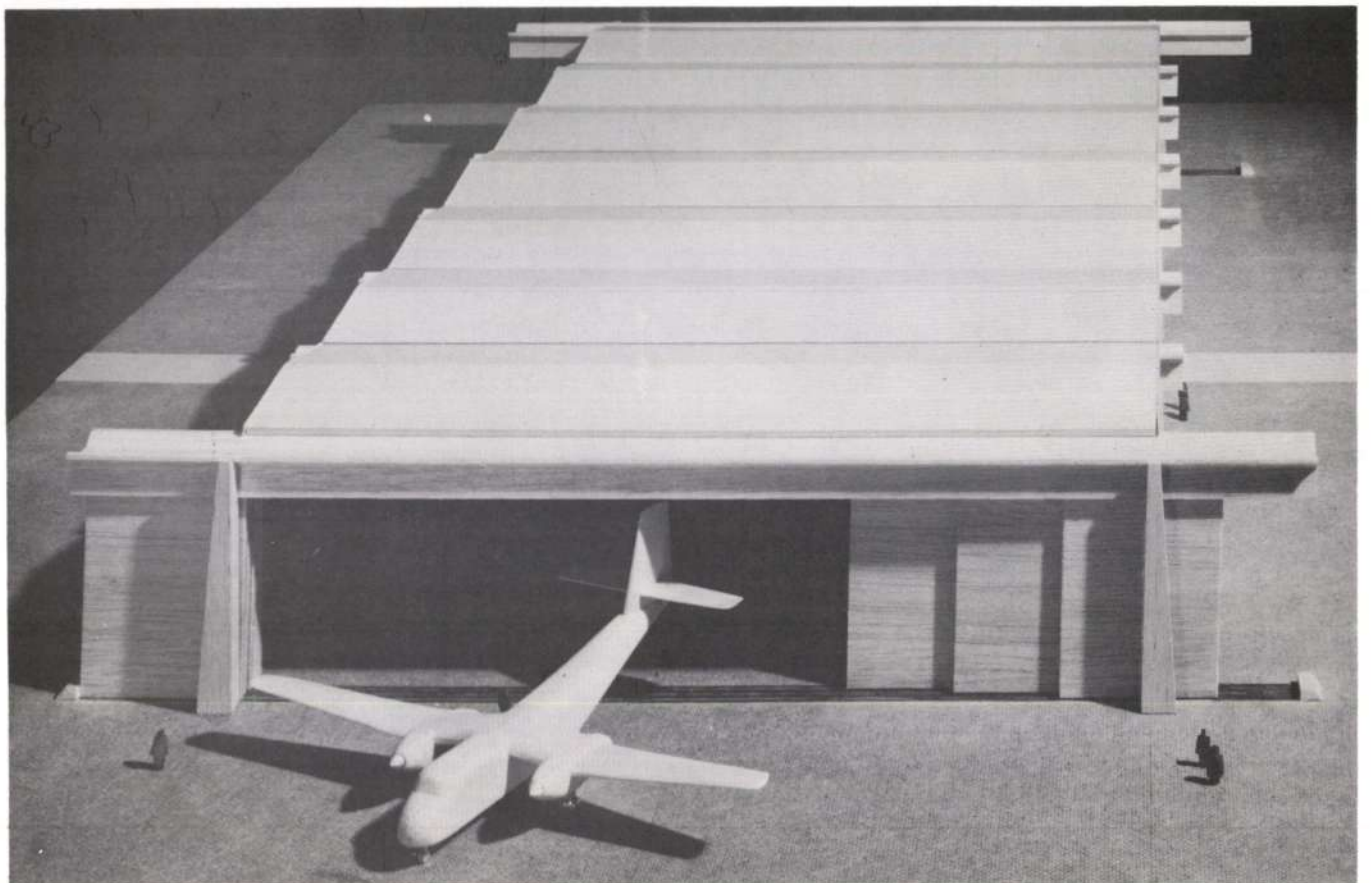
Fig. 8
Zambian Air Force hangar
(photo: Henk Snoek)

In complete contrast was the hangar for the Zambian Air Force. It was made of Balsa and card; and it took us five days complete with sliding doors and a de Havilland Caribou to go inside. This was due to perfect drawings and no amendments. Photographs almost turned it into the real thing.
