# THE ARUP JOURNAL

Vol. 4 No. 1 March 1969  
Published by  
Ove Arup & Partners Consulting Engineers  
Arup Associates Architects and Engineers  
13 Fitzroy Street, London, W1P 6BQ

Watford Central Area Redevelopment: Phase 3, by S. Jensen	2
The Avoncroft Museum of Buildings, by J. Martin	8
The rebuilding of the London Stock Exchange: The tower, by P. J. Thompson and D. M. Griffiths	11
Radio mast for Durham County Council Police Headquarters Ayckley Heads, City of Durham, by K. Anthony	17

## Watford Central Area Redevelopment: Phase 3

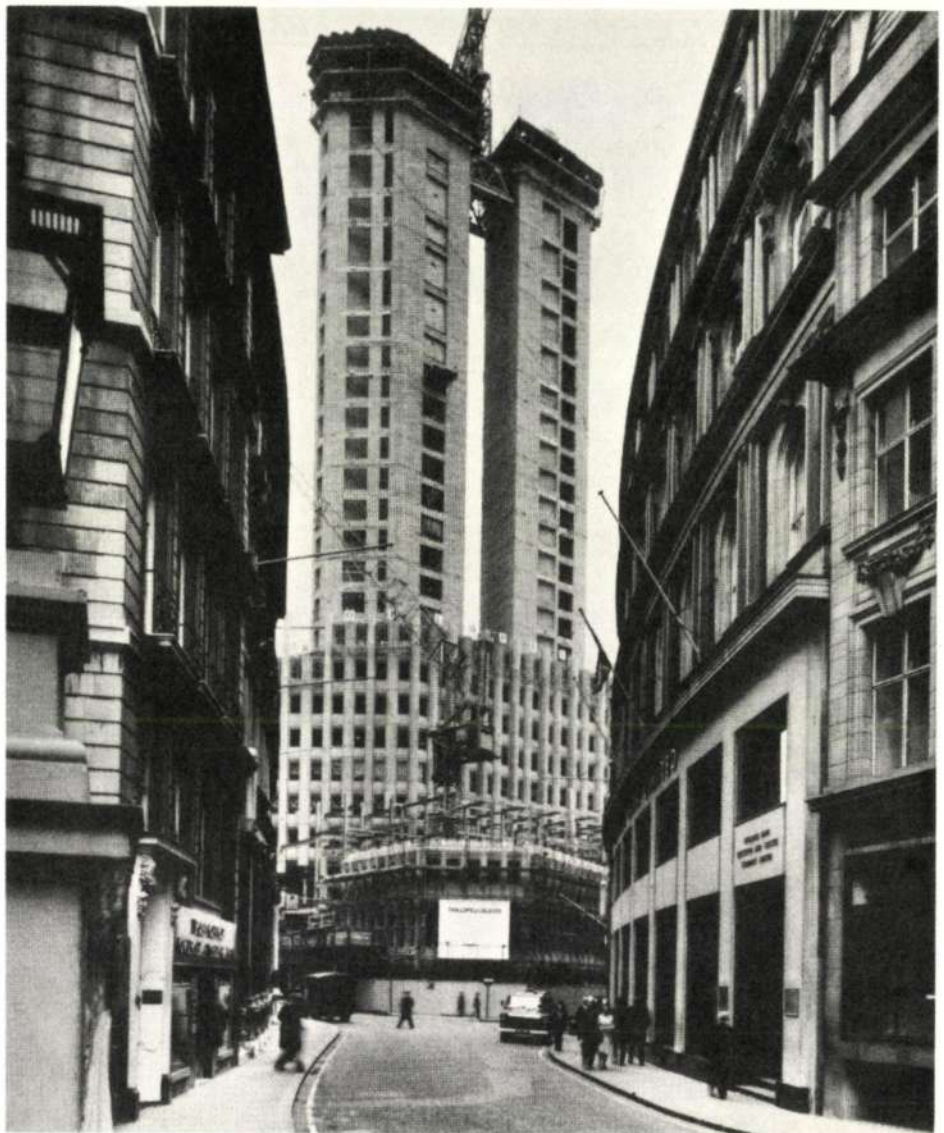
**Fig. 11 above**  
View of tower  
from Threadneedle Street, showing  
construction stage at December 1968  
(Photo: Sydney W. Newbery)

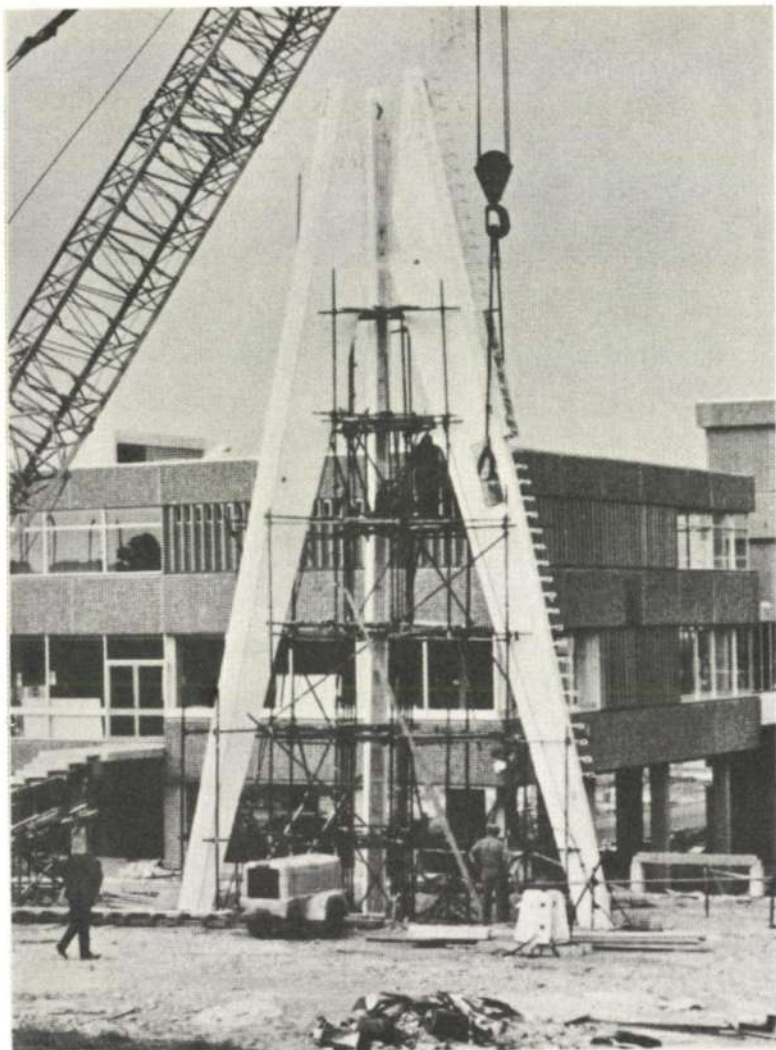
**Fig. 9**

A further stage. The main cranes have yet  
to slew towards each other. Note the  
smaller mobile crane supporting the lower  
end of the mast (Photo: Turners  
(Photography) Ltd., Newcastle)

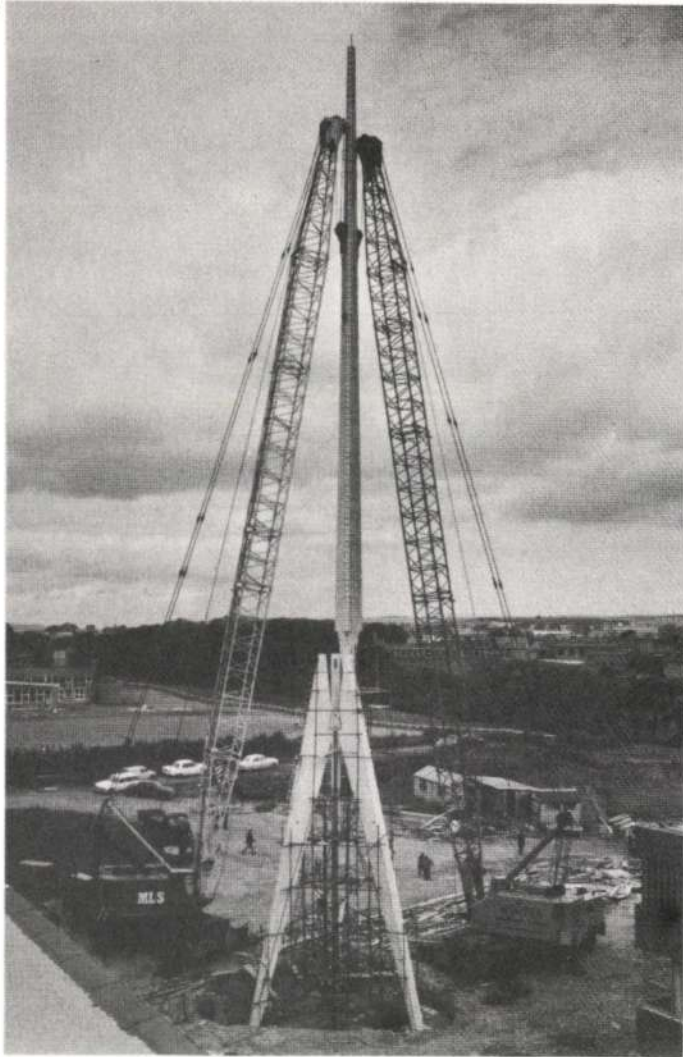
**Fig. 10**

Now in the vertical position, there is very little clearance at the heads of the cranes. (Photo: Turners (Photography) Ltd., Newcastle)

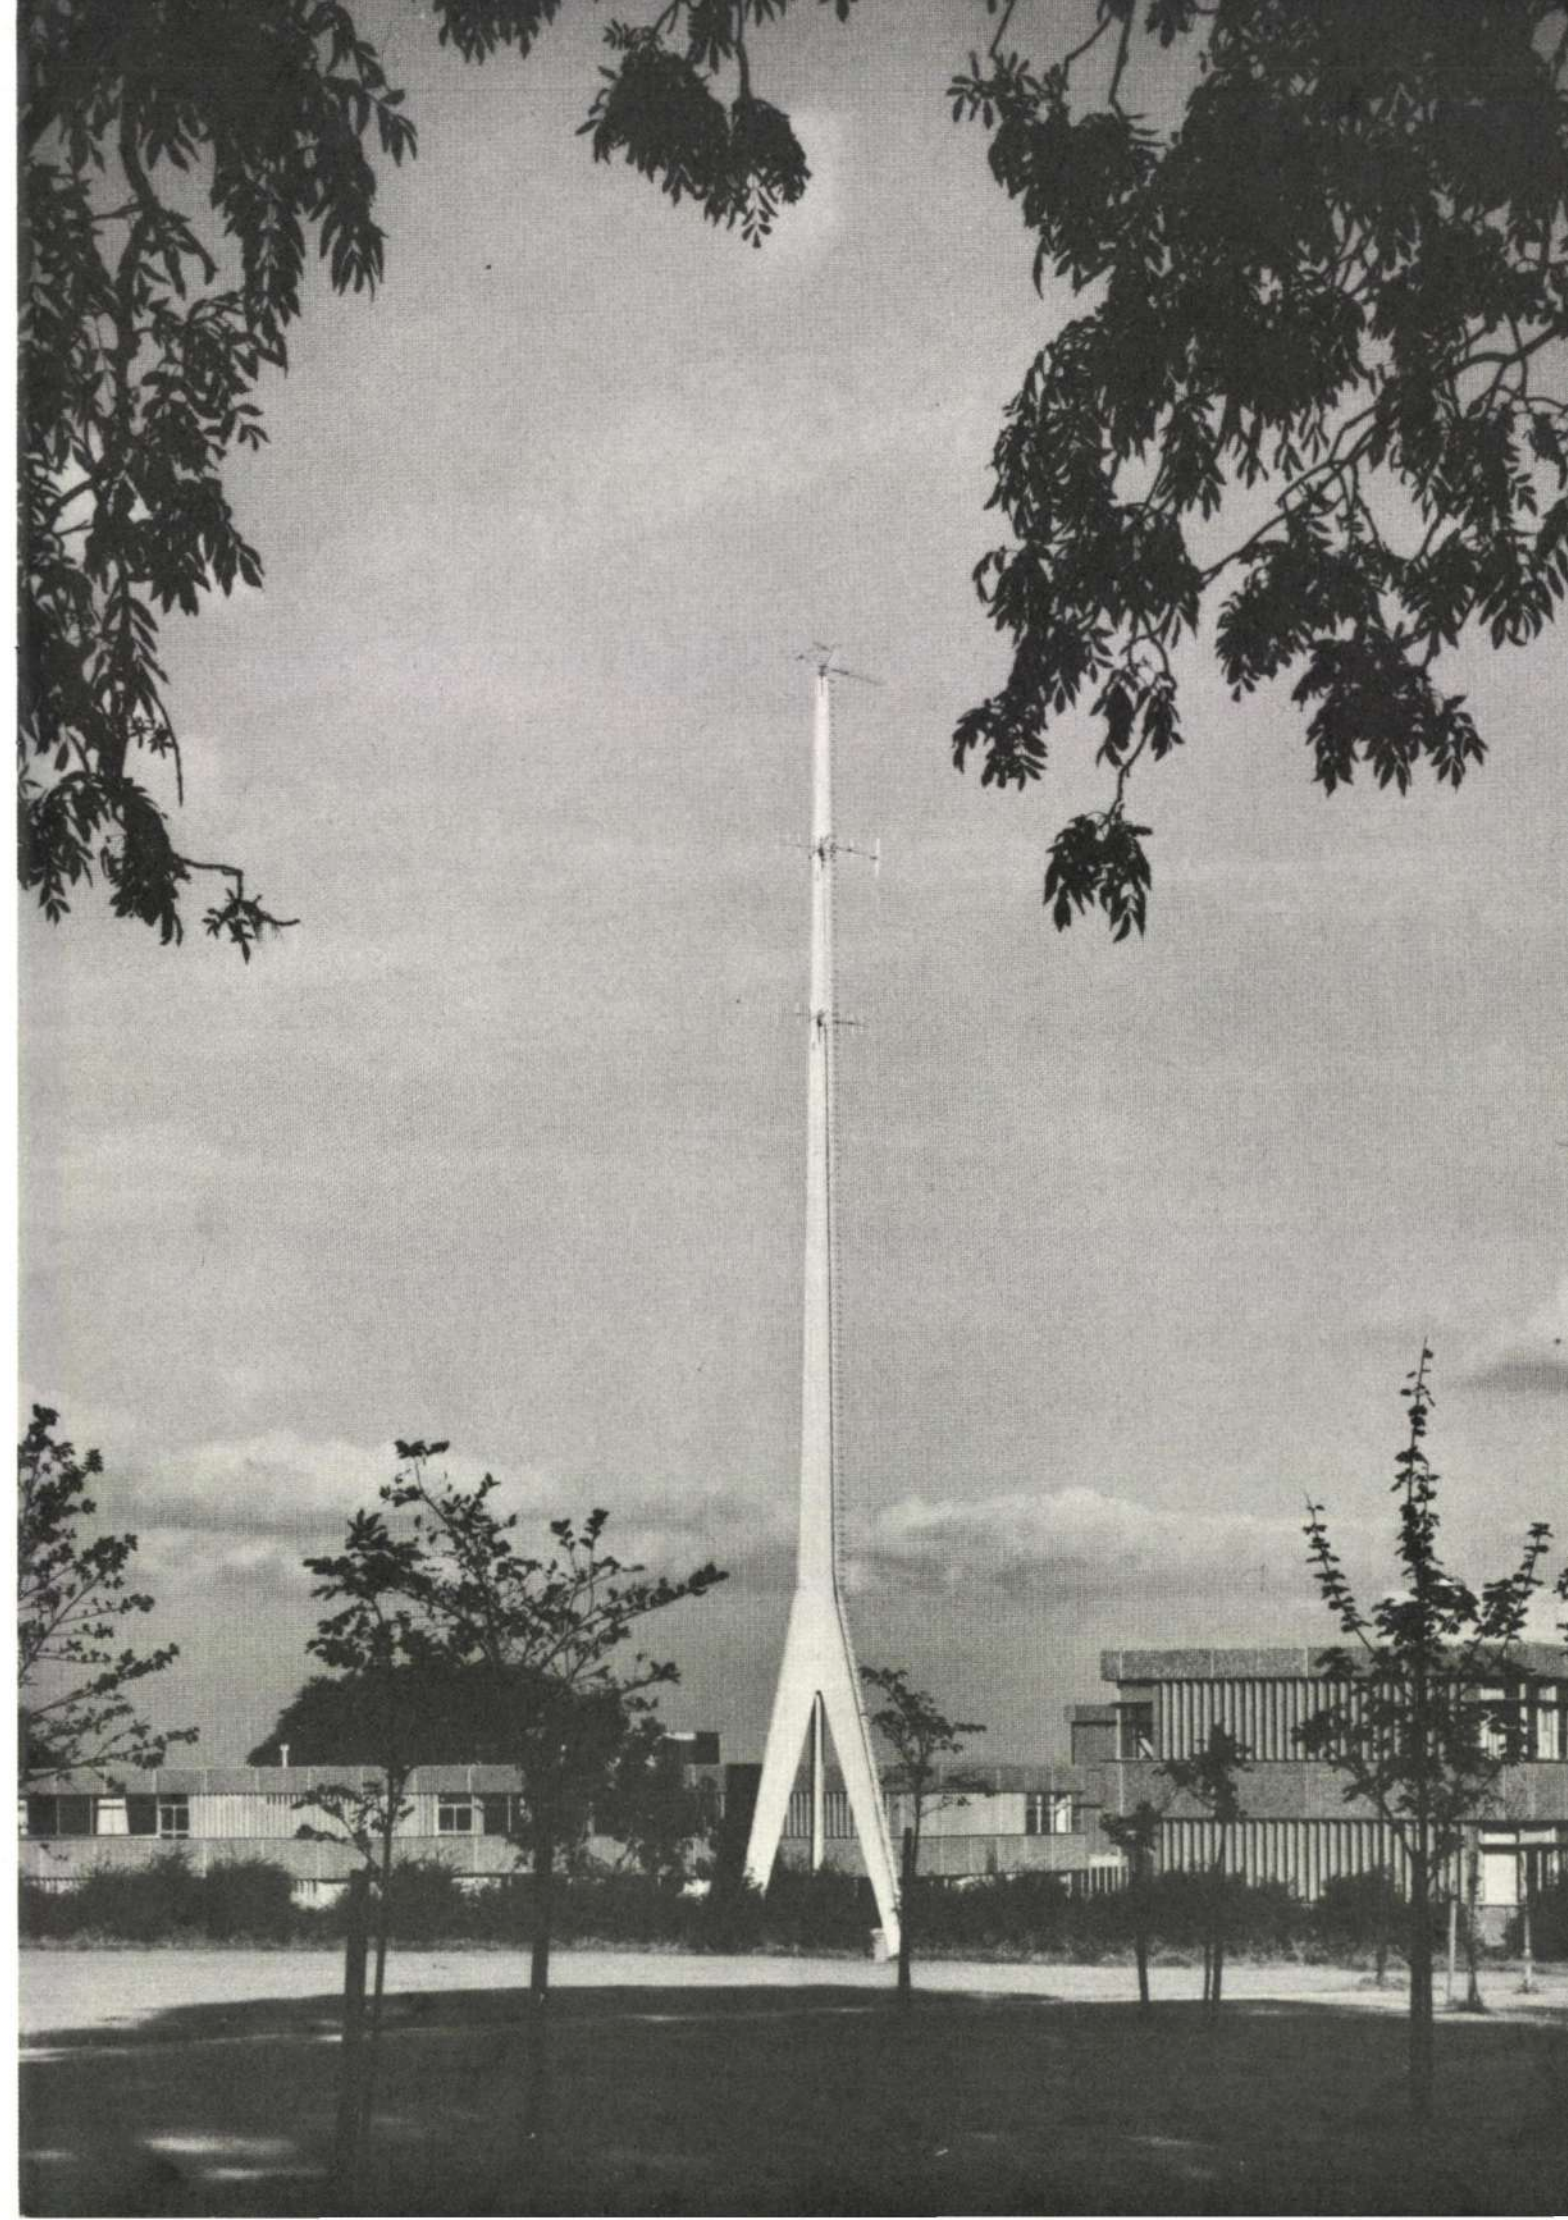
**Fig. 14 on facing page**

The finished job (Photo: Turners (Photography) Ltd., Newcastle)
