THE ARUP JOURNAL

SUMMER 1988

Vol.23 No.2 Summer 1988
Published by
Ove Arup Partnership
13 Fitzroy Street, London W1P 6BQ

Arup Geotechnics

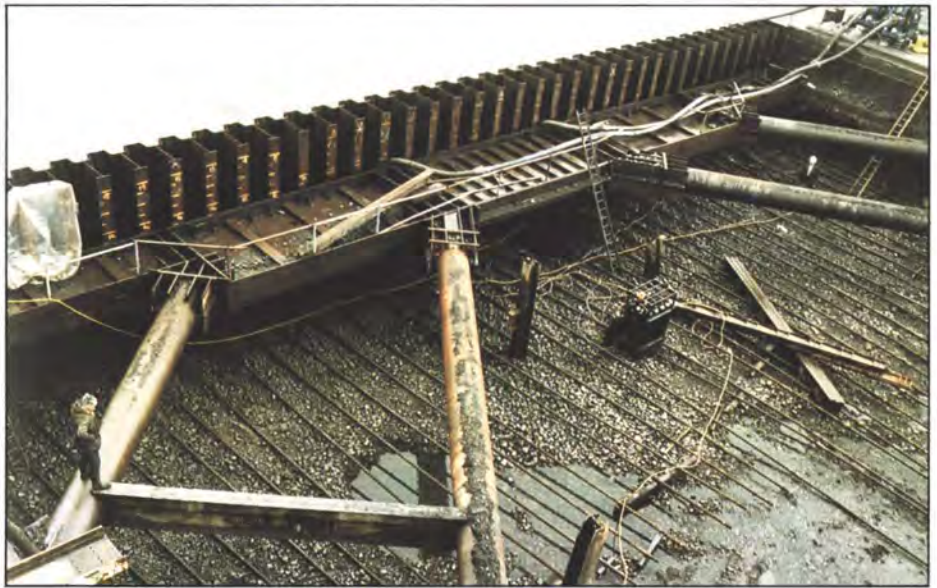
Methil: Sheet pile wall and below: Load test on compacted fill

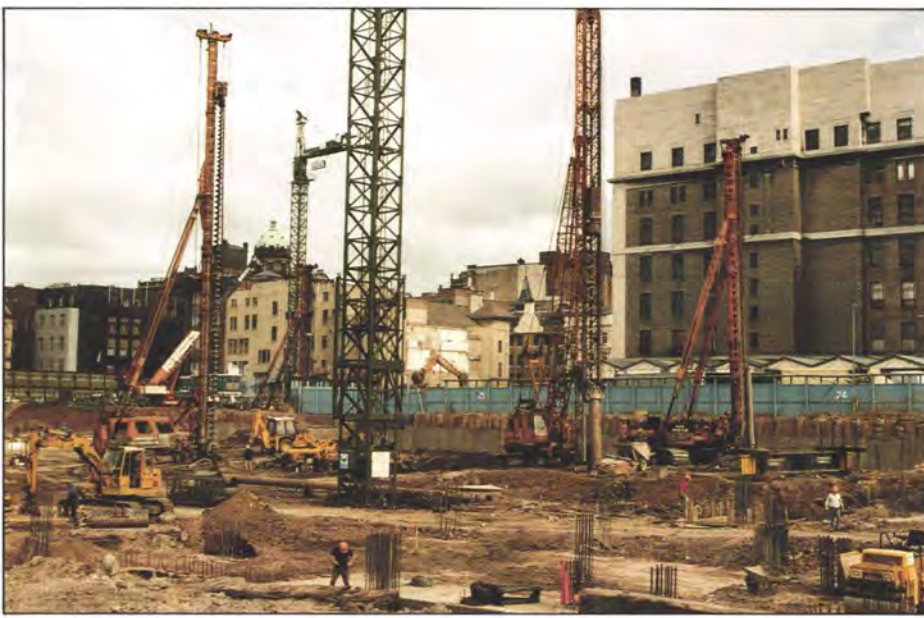
Continuous flight auger piling, St Enoch Square, Glasgow

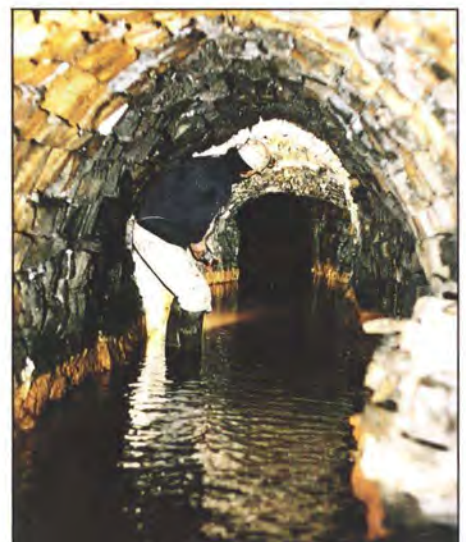
Cae Harris ironstone workings: above, condition survey; below, roadway

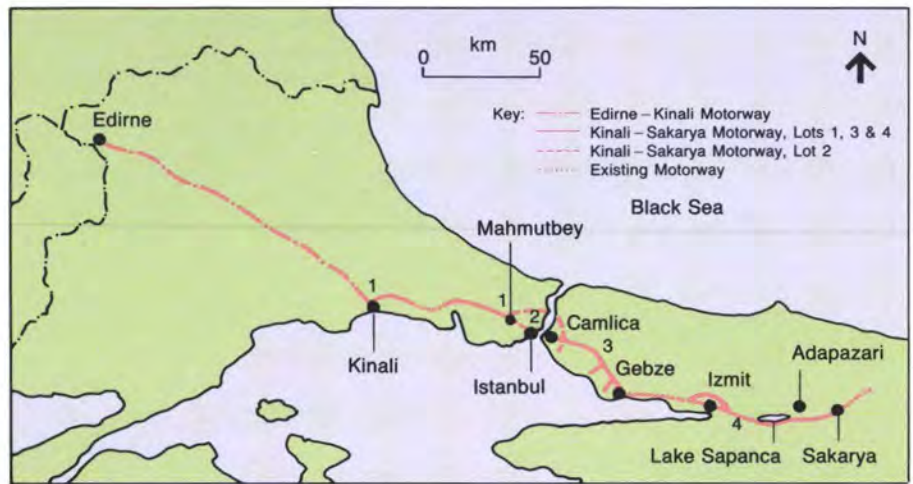
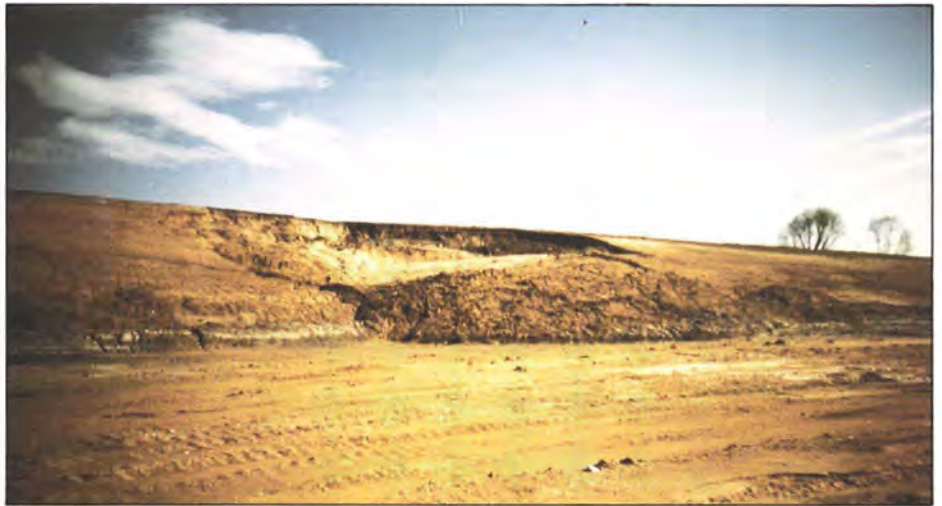
Above and below: Slope failure.

In May 1986 construction started on sections 1 and 4B of the motorway. Within a month or so of commencement of excavation of one of the major cuts in section 1, the cutting side slopes had slipped at least twice. Furthermore, following the excavation of another cutting, the wells supplying a nearby army camp dried up. As a result Ove Arup & Partners were asked by the Turkish Ministry of Public Works and Settlement (KGM) to undertake a geotechnical appraisal of section 1, and this was extended to include section 4. Working in conjunction with Bogazici University, we undertook this work between September and November 1986.

The section to the west of Istanbul passes through considerable areas of a geological formation known as Istanbul Green Clay; this formation was present in the cutting which had experienced landslipping during construction. Examination of aerial photographs showed a history of slope instability in the worst affected area; natural slopes were inclined at 1:6 to 1:9, whereas the cutting slopes had been designed at 1:3. Examination of the strata exposed in the cuttings in the areas of land slipping indicated that the Istanbul Green Clay Formation was much more complex than had been assumed by the original designers. It would appear to consist of an overlying stratum of sand which contained a number of thin continuous

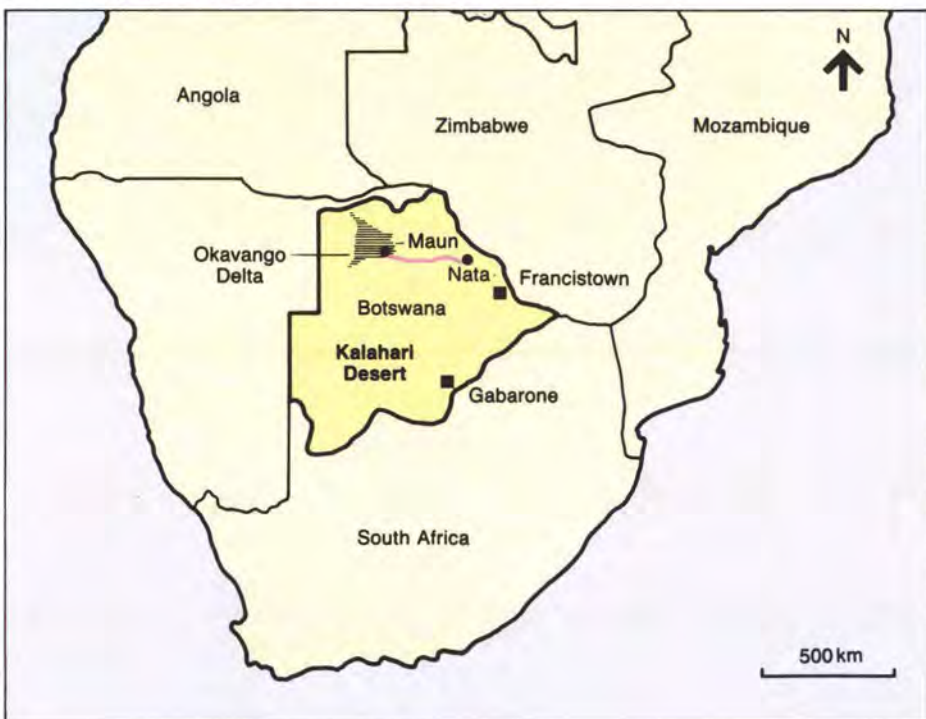
Below: The proposed route of the Nata-Maun Road

The loan agreement to finance construction was signed in February 1988 and work should begin in the near future.

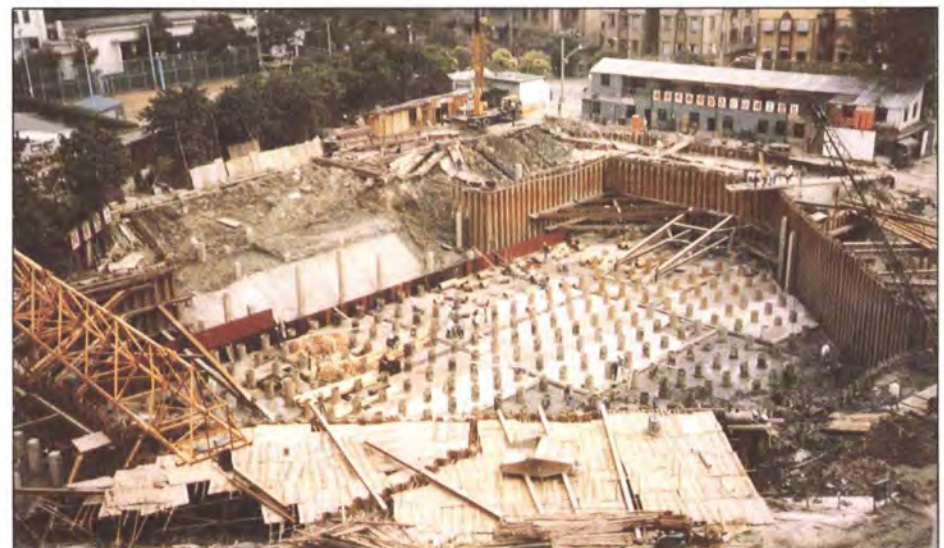
Jin Cang Mandarin Hotel: driven steel piles

Cang Mandarin is presently under construction. The foundations comprise 40m long steel pipe piles (see photo below) driven to a thin sand layer within the alluvium. Consolidation of the clay is expected to result in 150mm settlement of each hotel tower.

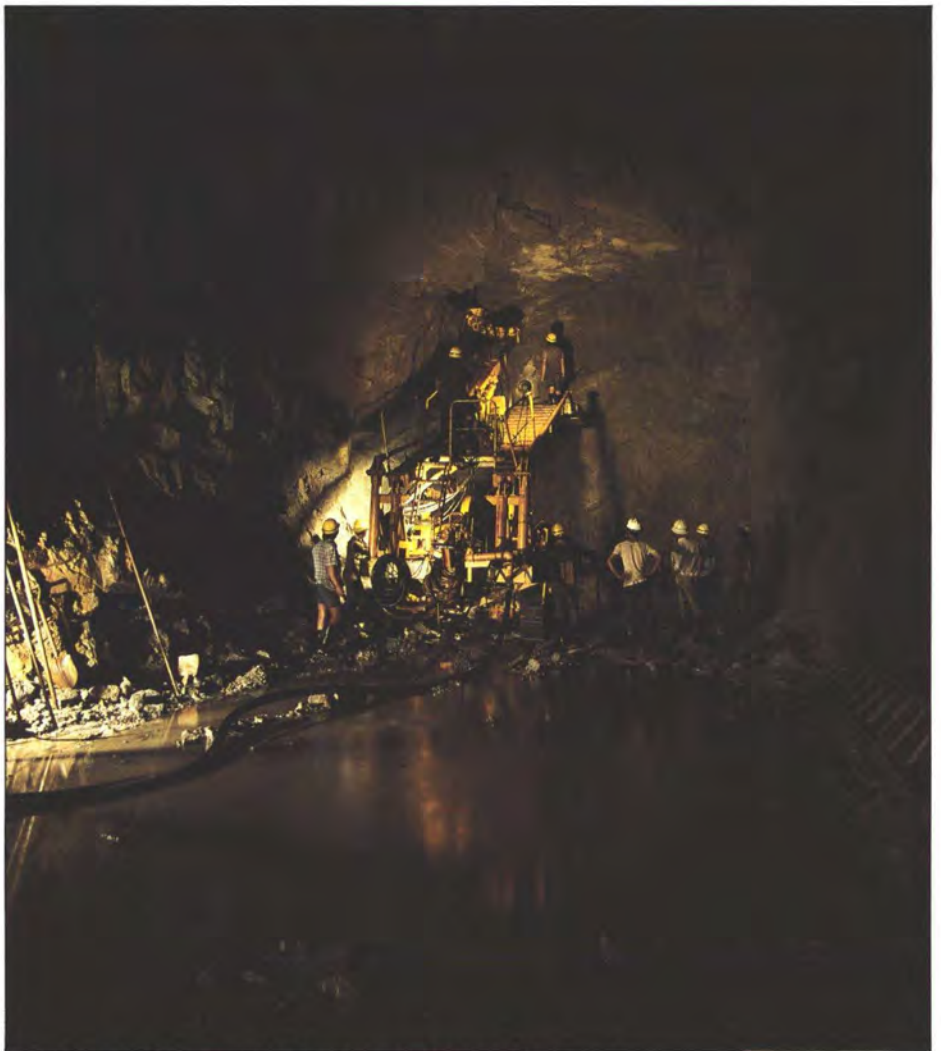
Sea water tunnel construction, Hongkong Bank (Photo: N. Farrin)

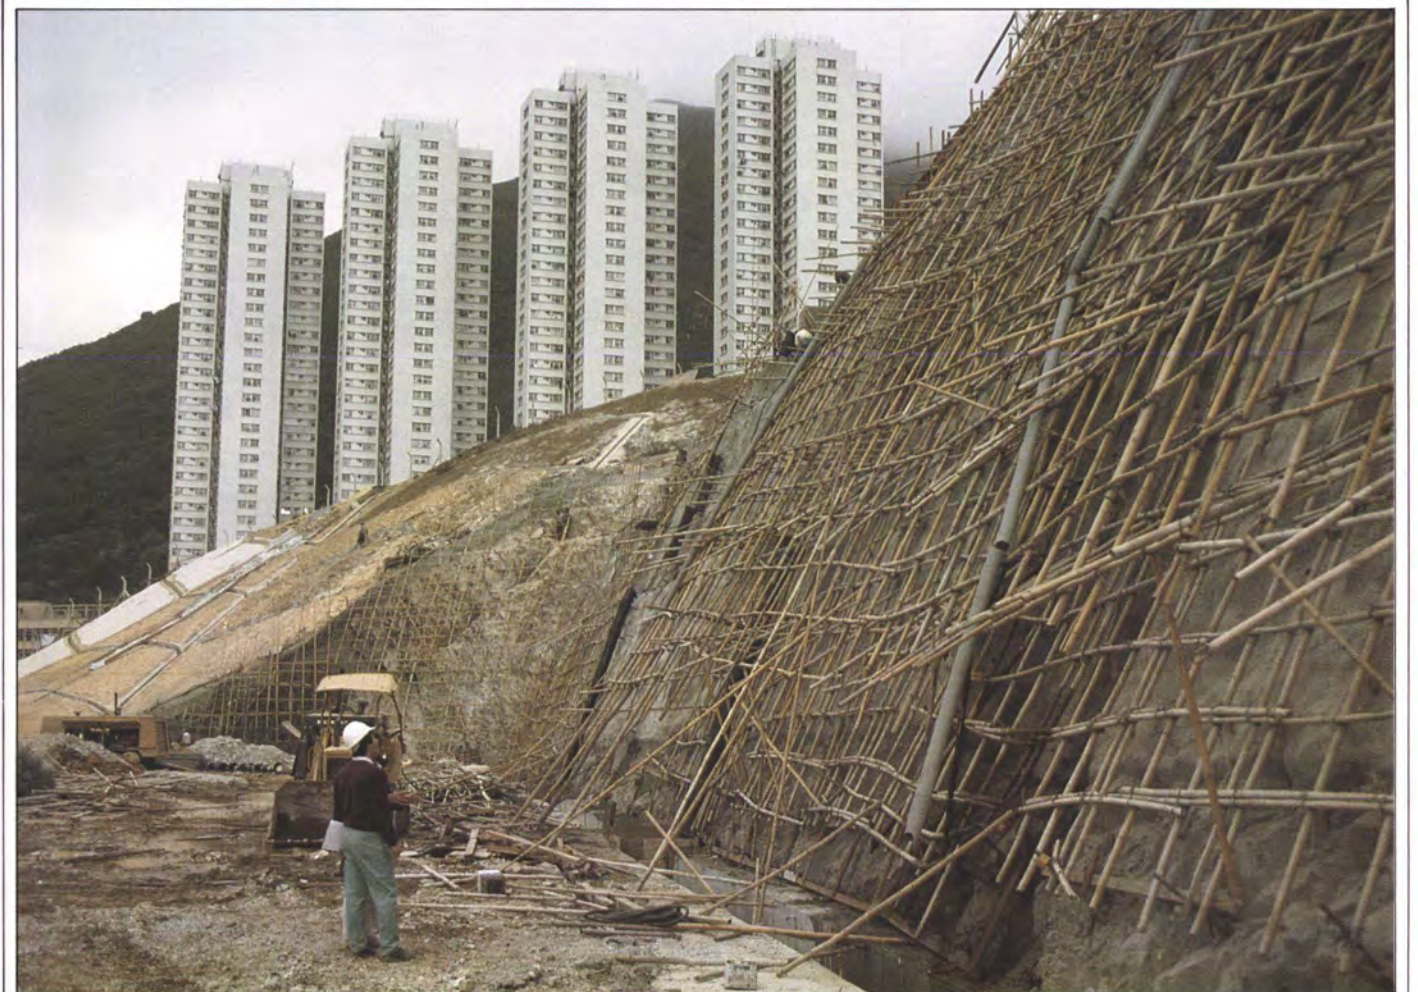
Hong Kong housing authority, slope remedial works (Photo: Martyn Stroud)

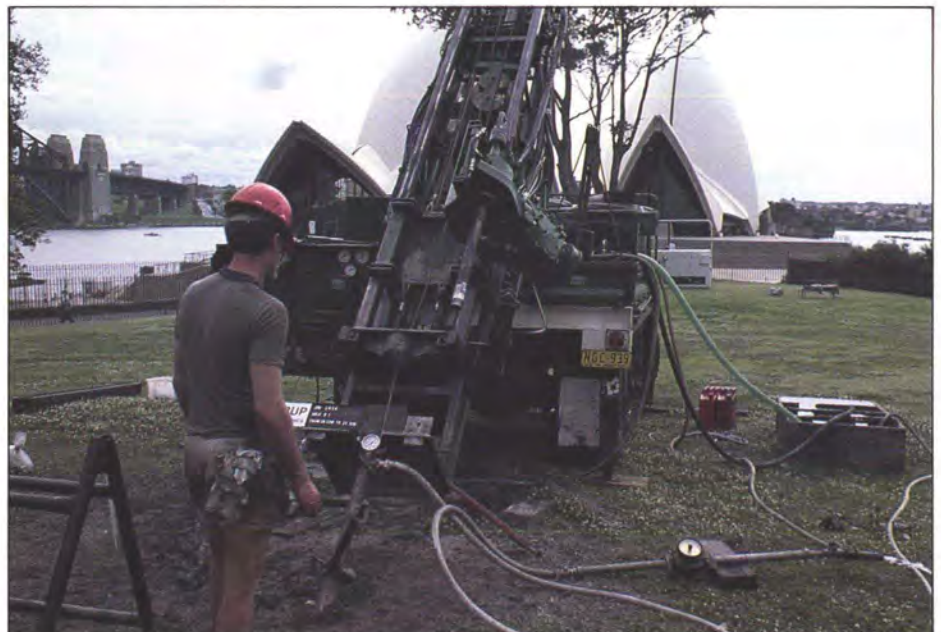
Proposed Bennelong Point underground car park: In situ permeability testing
